DuPont Chestnut Run
Corrective Action Evaluation
May 26, 2006 Site Visit Notes by Diane Schott

Inspection Results (in approximate order of inspection):

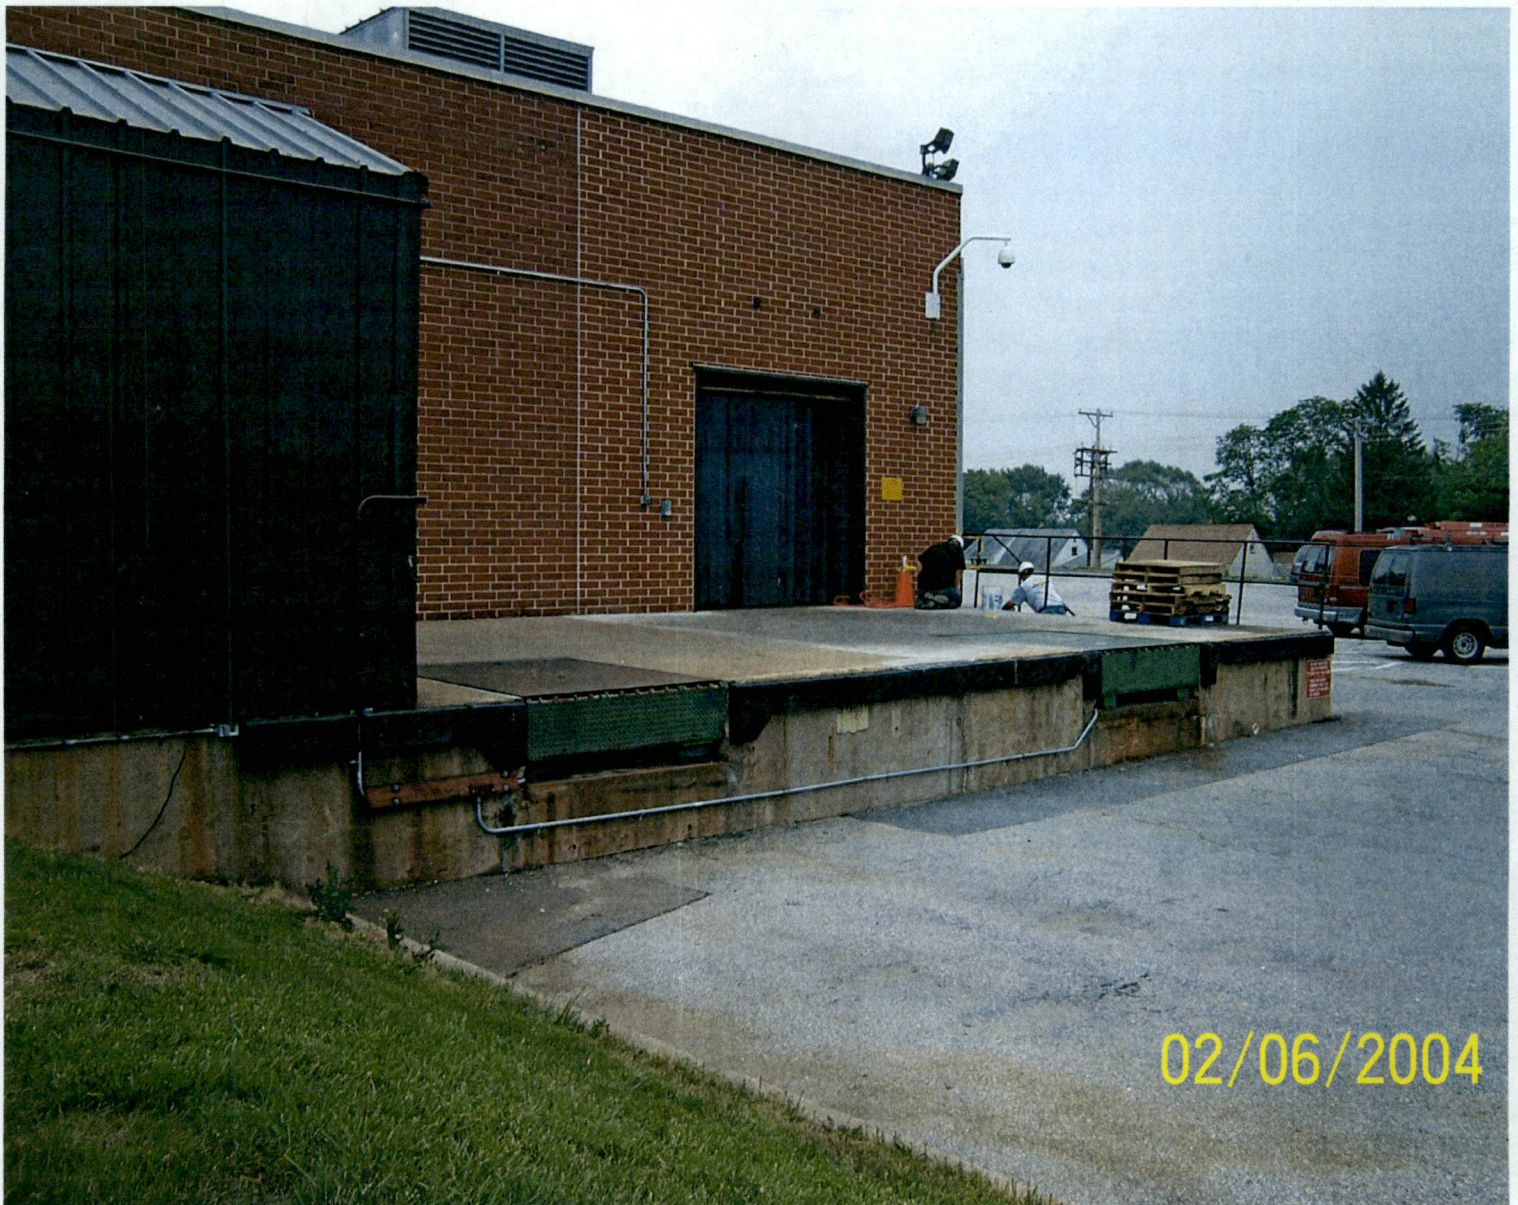
Located on a concrete dock.

Current storage area is constructed with corrugated metal walls that appear in good – possibly new condition.

Metal walls contain a gap between the bottom of the wall and the concrete base (dock) - such that any liquid or storm water drainage could flow off of dock and onto adjacent soil.

No visual evidence of release.

EPA Photo #1- SWMU 11 Metal Sides over Dock

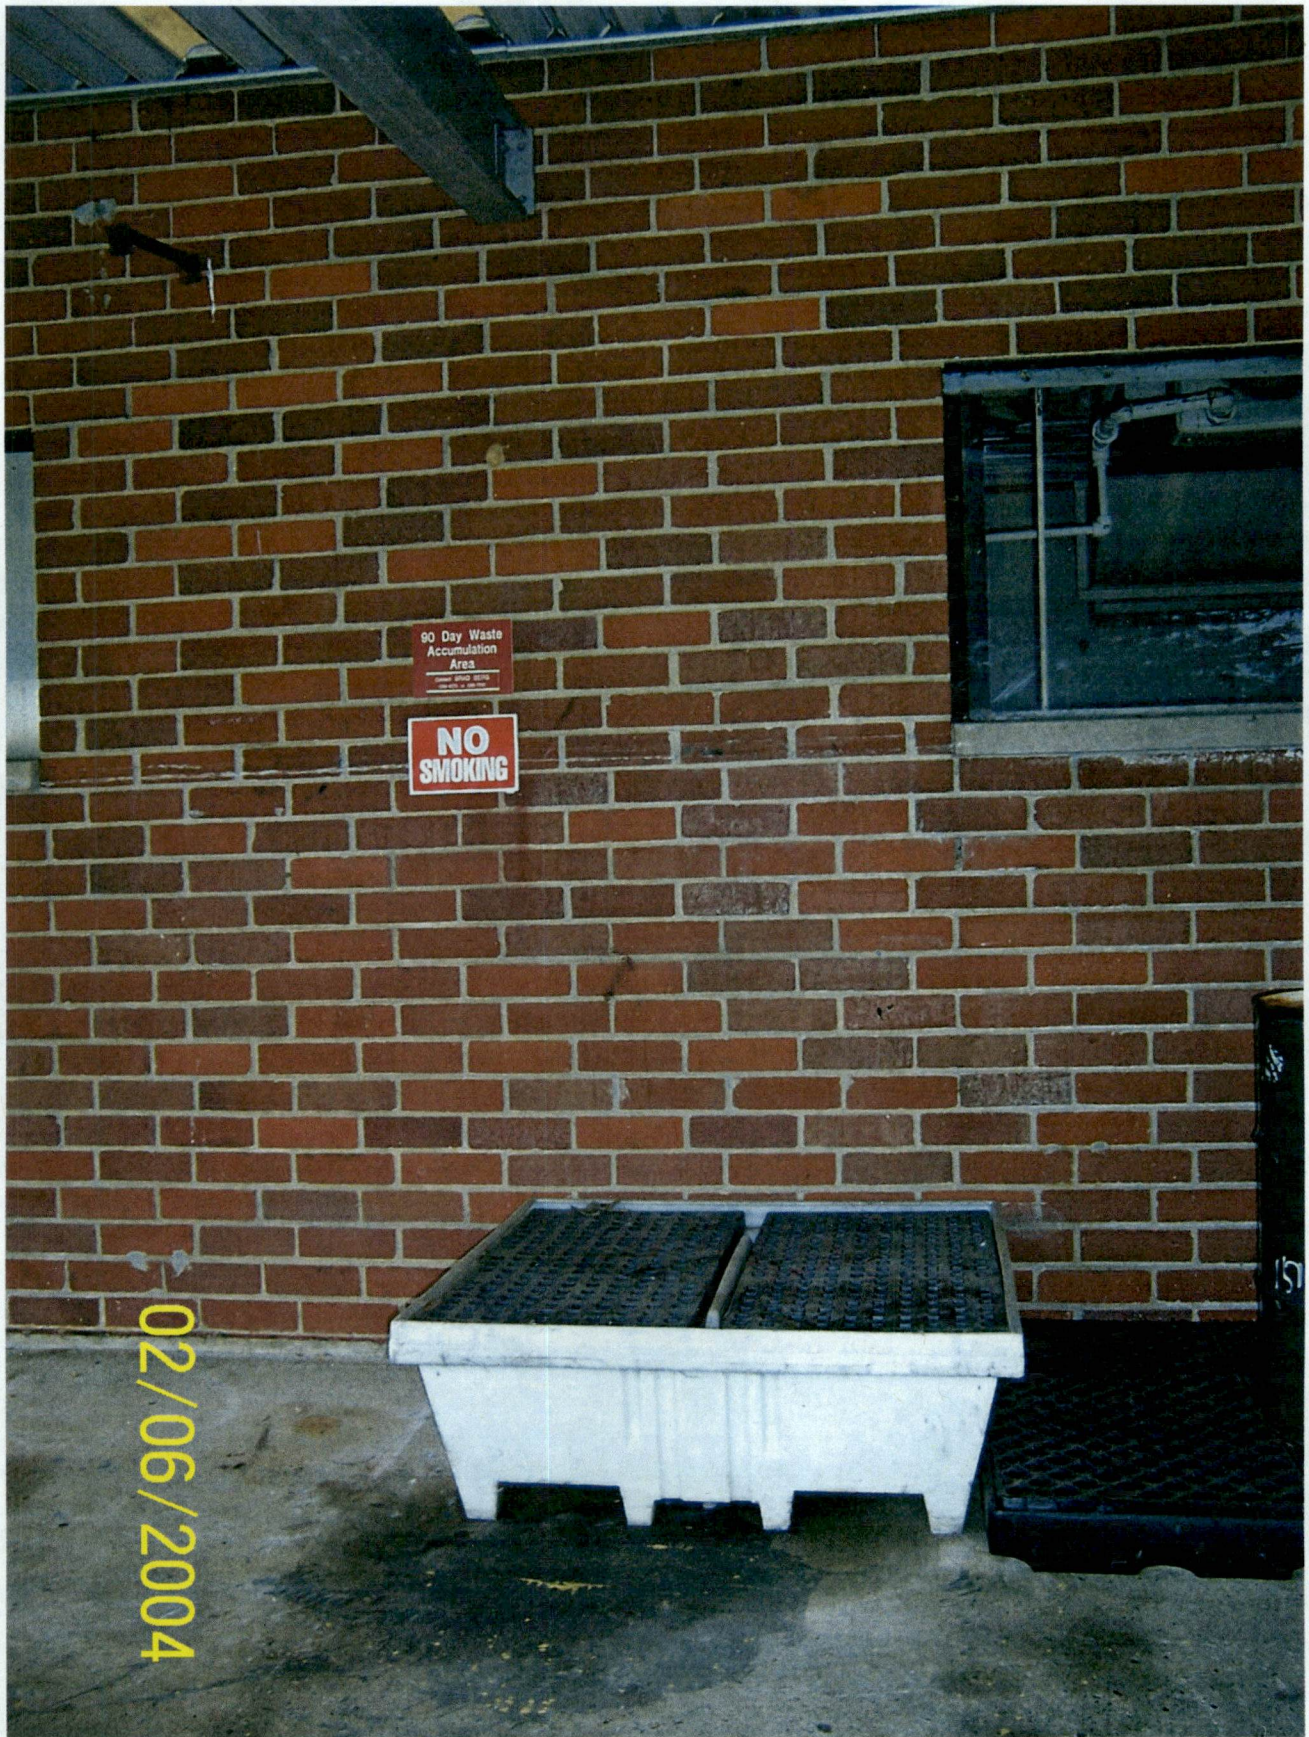
Drums and storage containment pad appear in excellent - possibly new-condition.

Black stain is present on concrete below storage containment pad.

Stain appeared surficial.

EPA Photo # 2: SWMU 34 Stain on Concrete

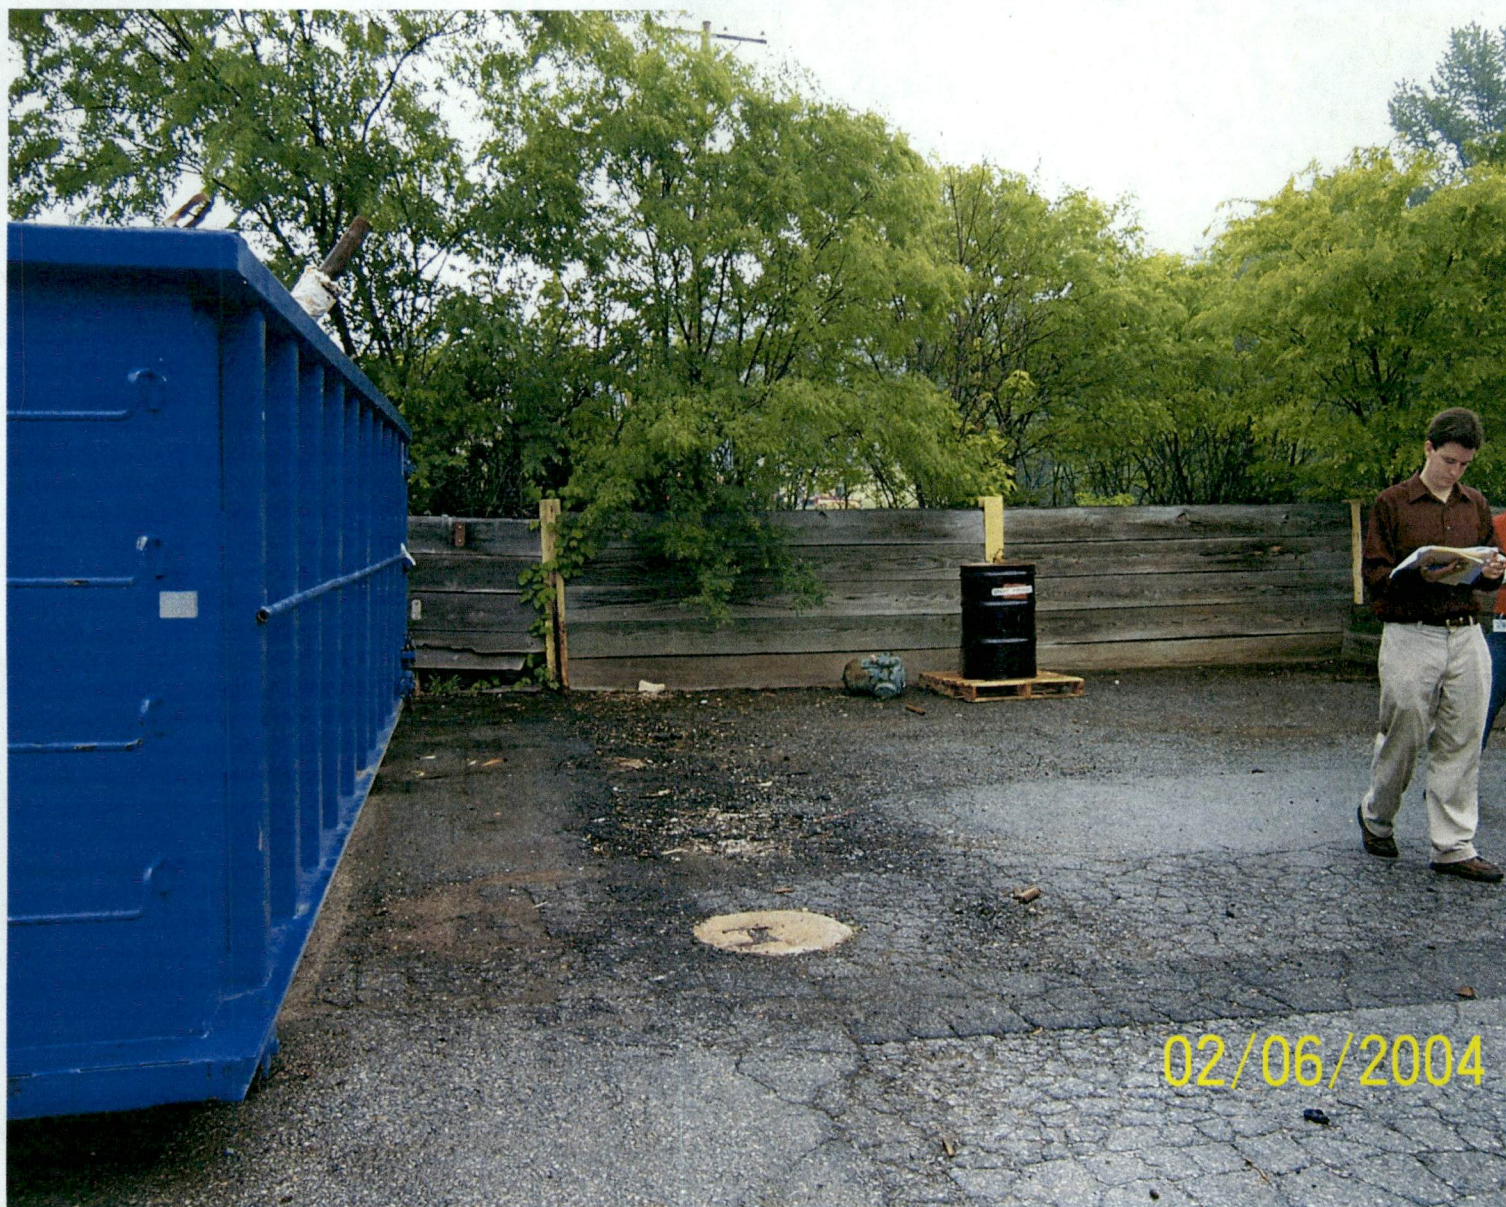
Entire area appeared to be an older storage area, parts of which were updated to conform to RCRA requirements.

Older surface areas and possible pre-RCRA conditions did not appear sufficient to contain a release.

Area is adjacent to a creek

No visual evidence of release.

EPA Photo #3: SWMU 16 and Surrounding Area

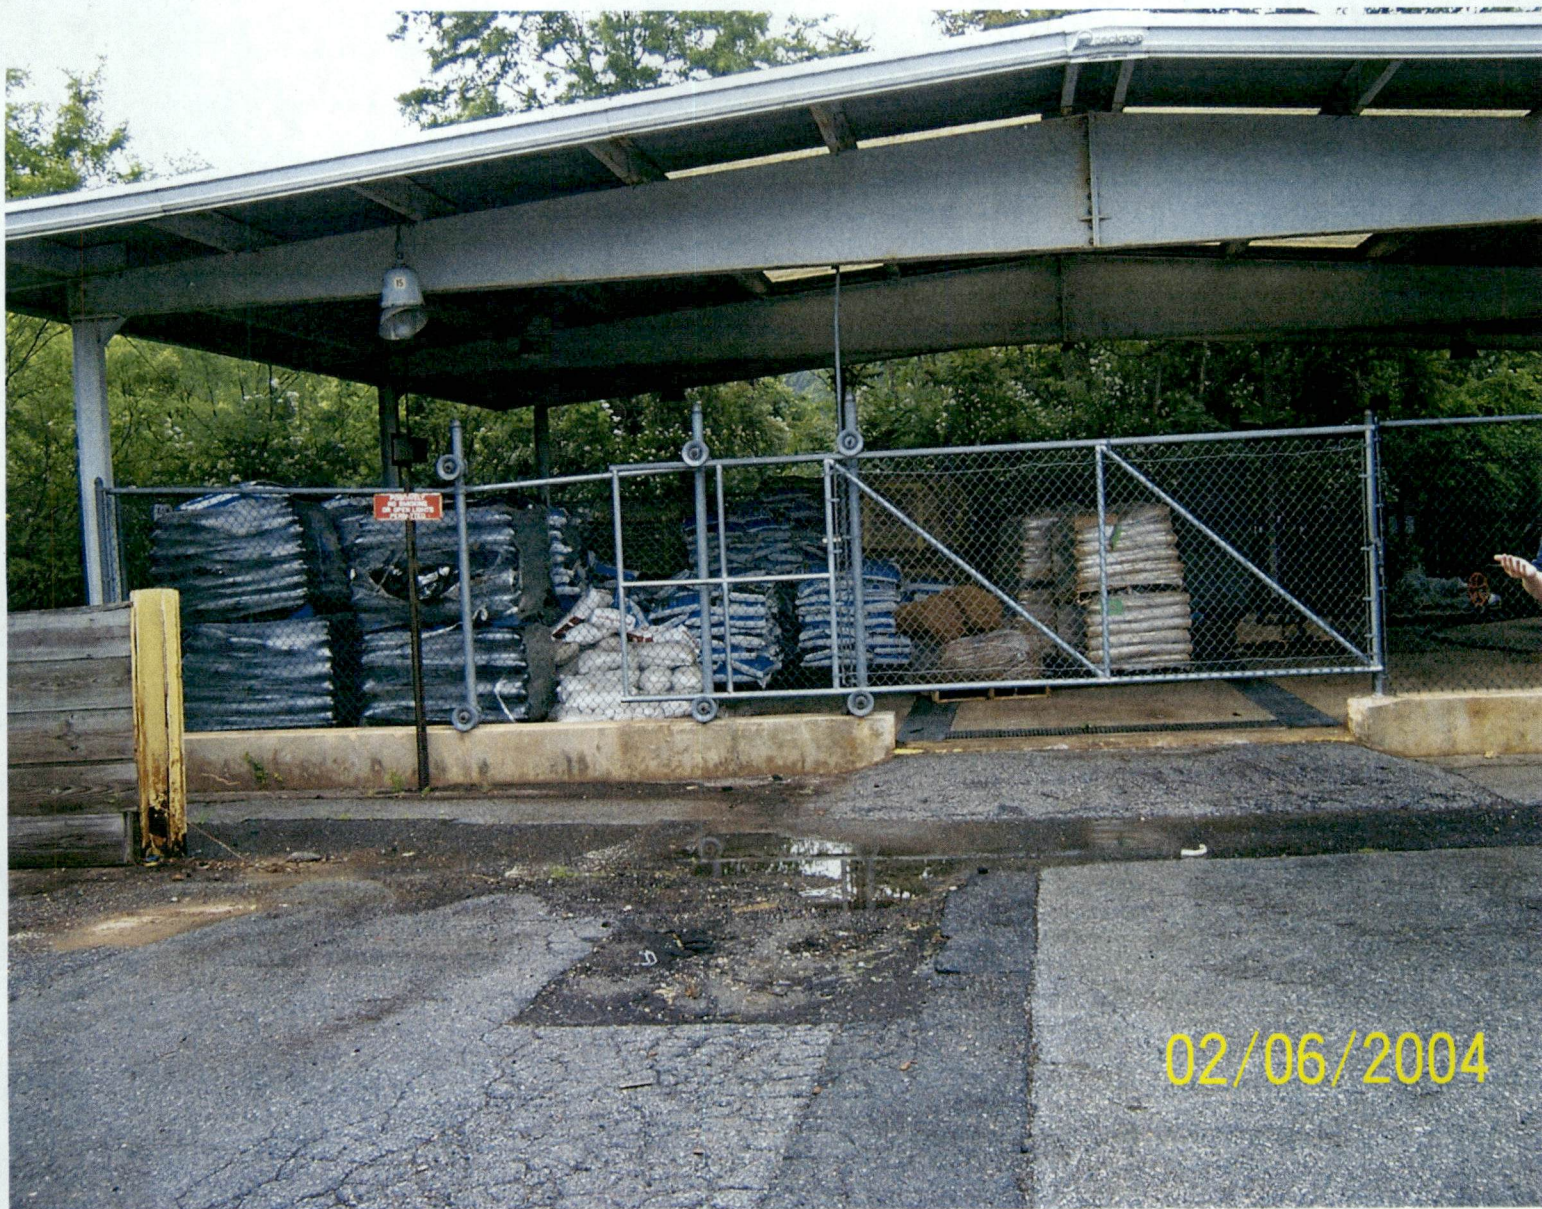
Drain is located between SWMU 1 and creek.

EPA Photo #4: SWMU 1 - Former Hazardous Waste Storage Area

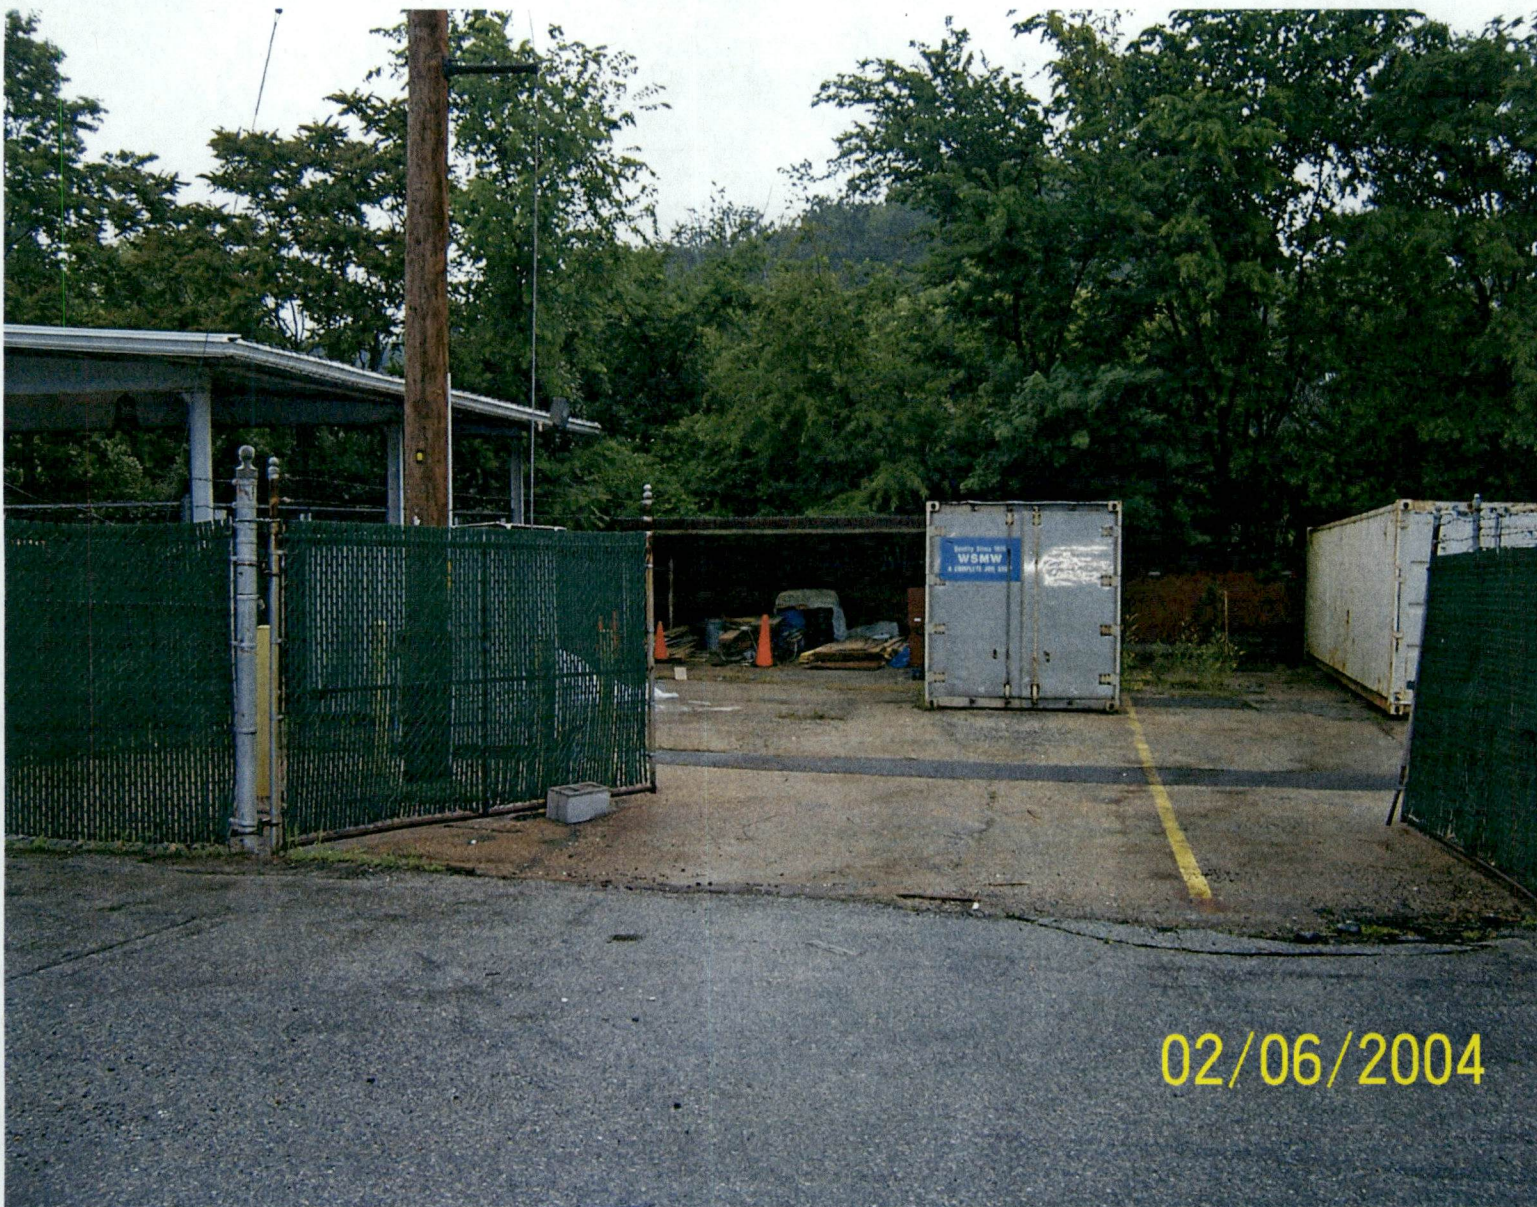
EPA Photo #5: SWMU 22 - Scrap Metal Storage Area

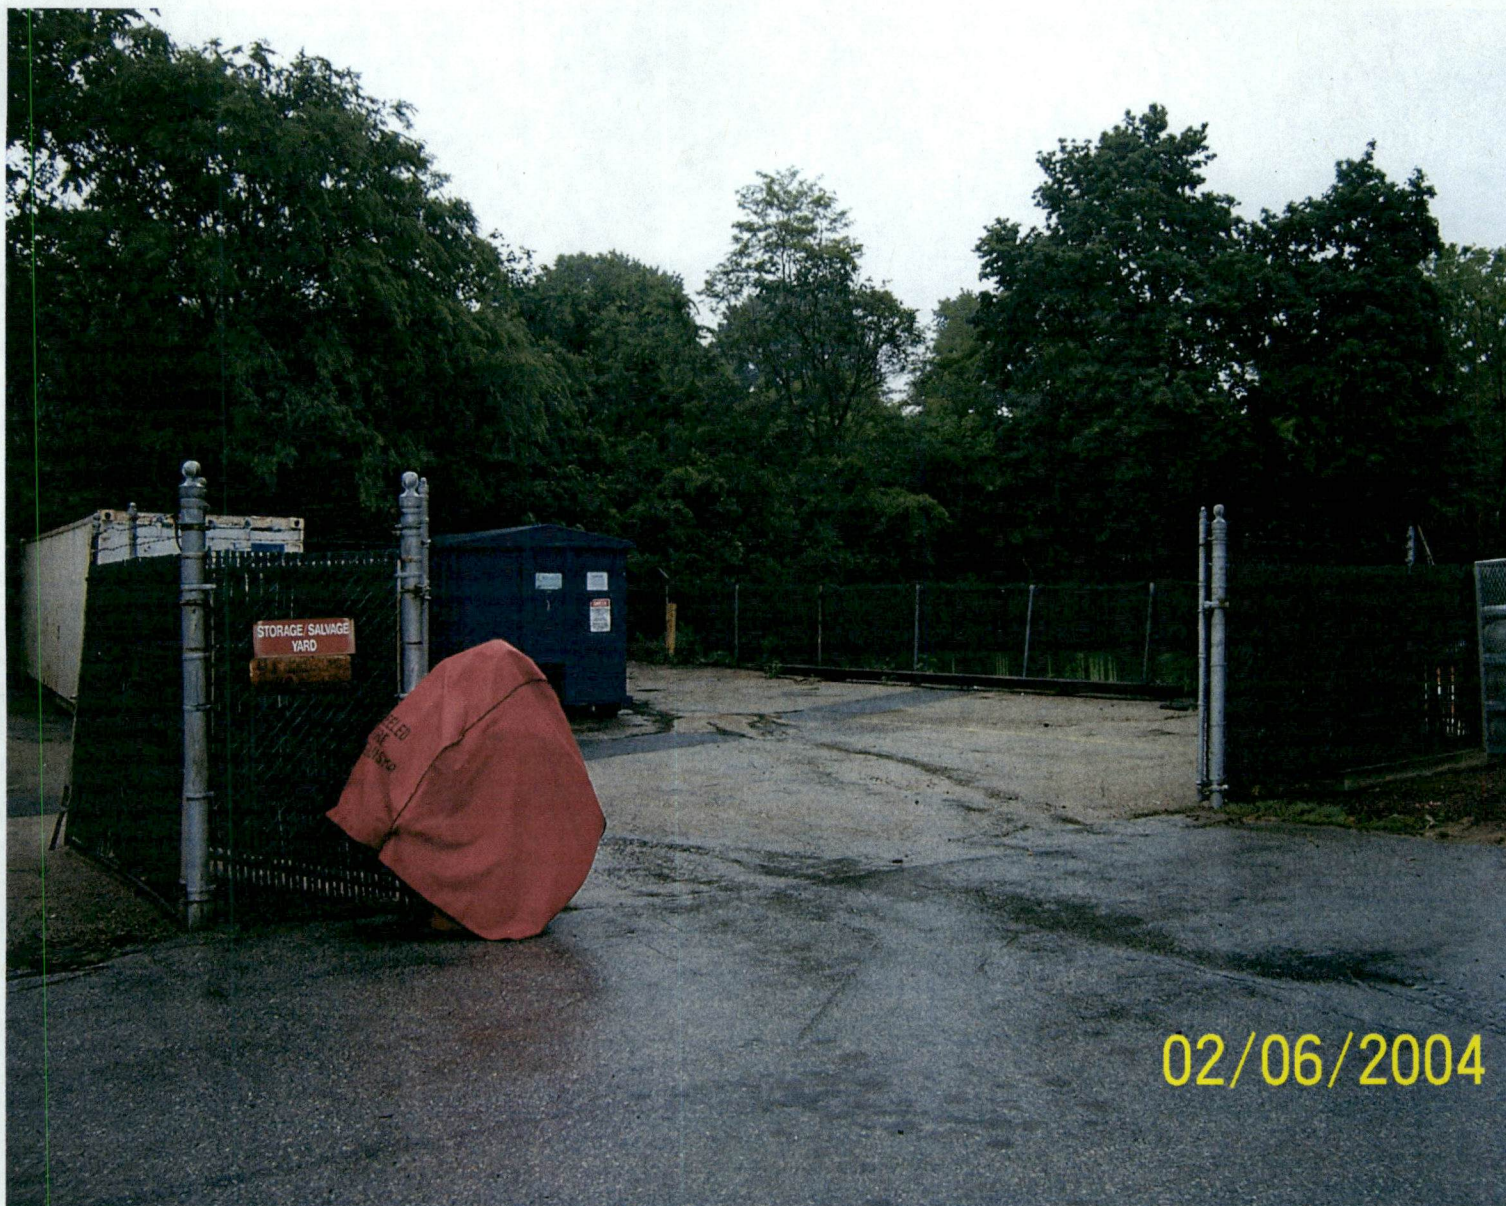
EPA Photo #6: SWMU 22 - Scrap Metal Storage Area

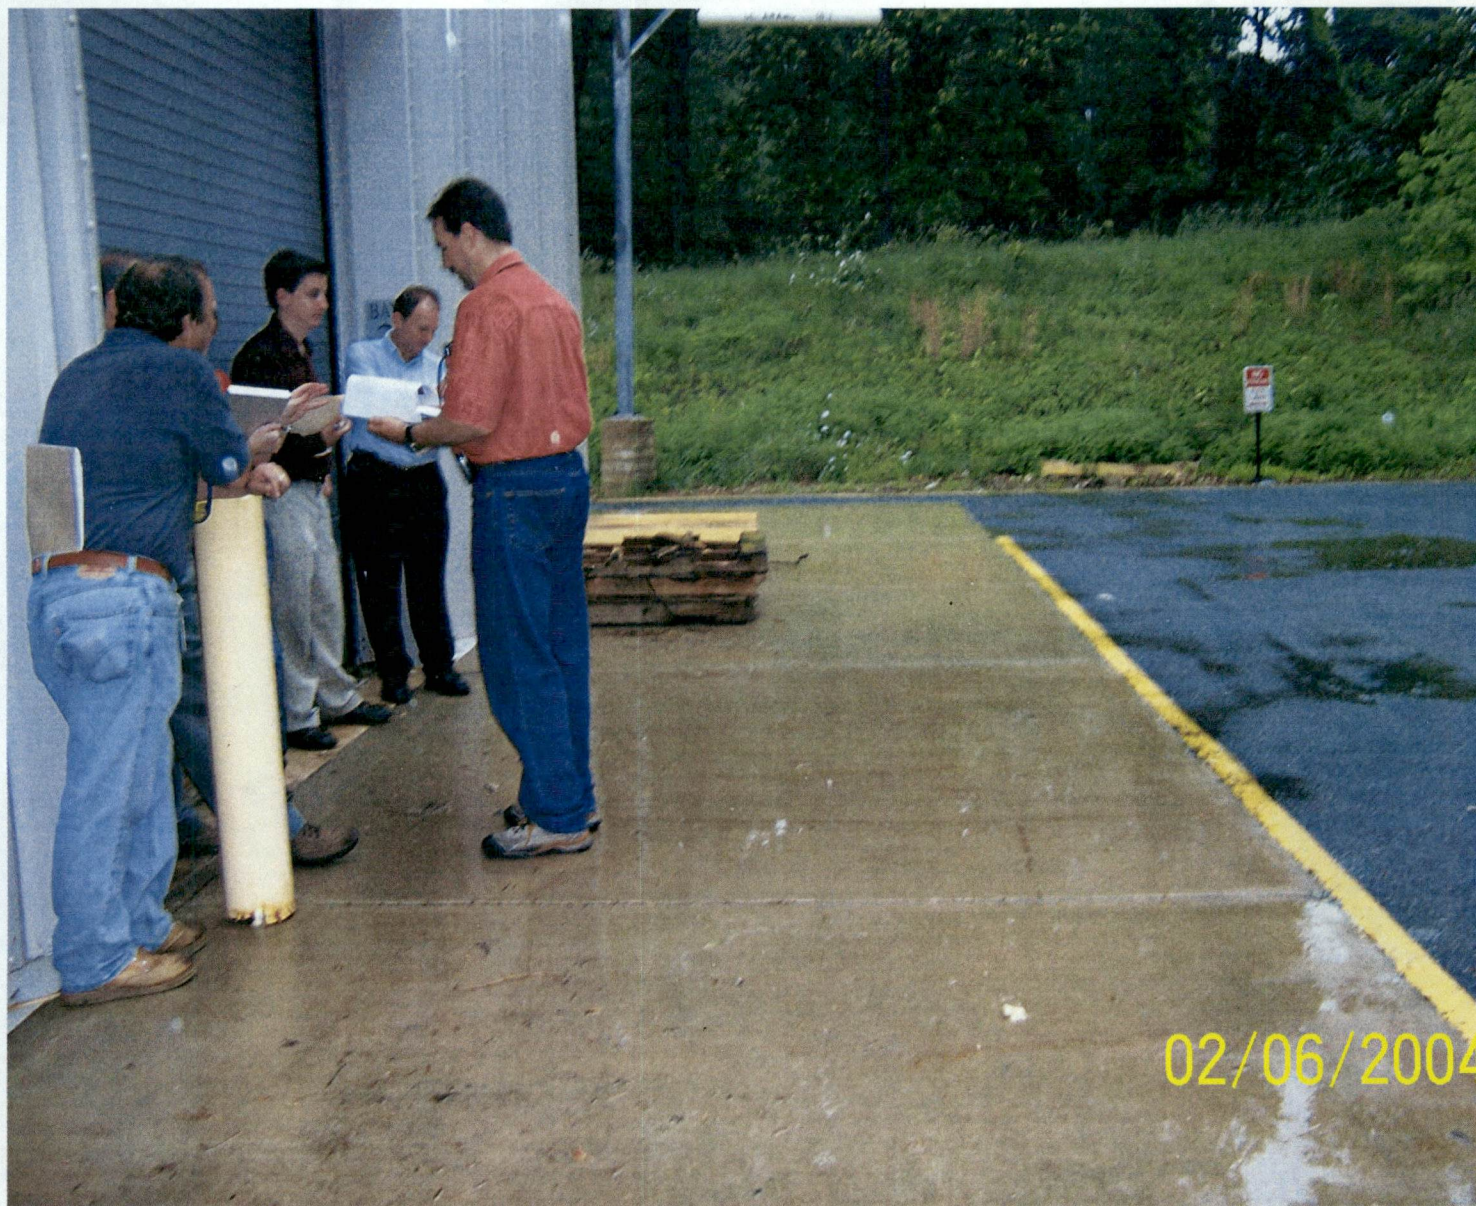
Location is flat with drainage to adjacent parking and soil areas.

No visual evidence of release.

EPA Photo #7 SWMU 4 - Flat Location

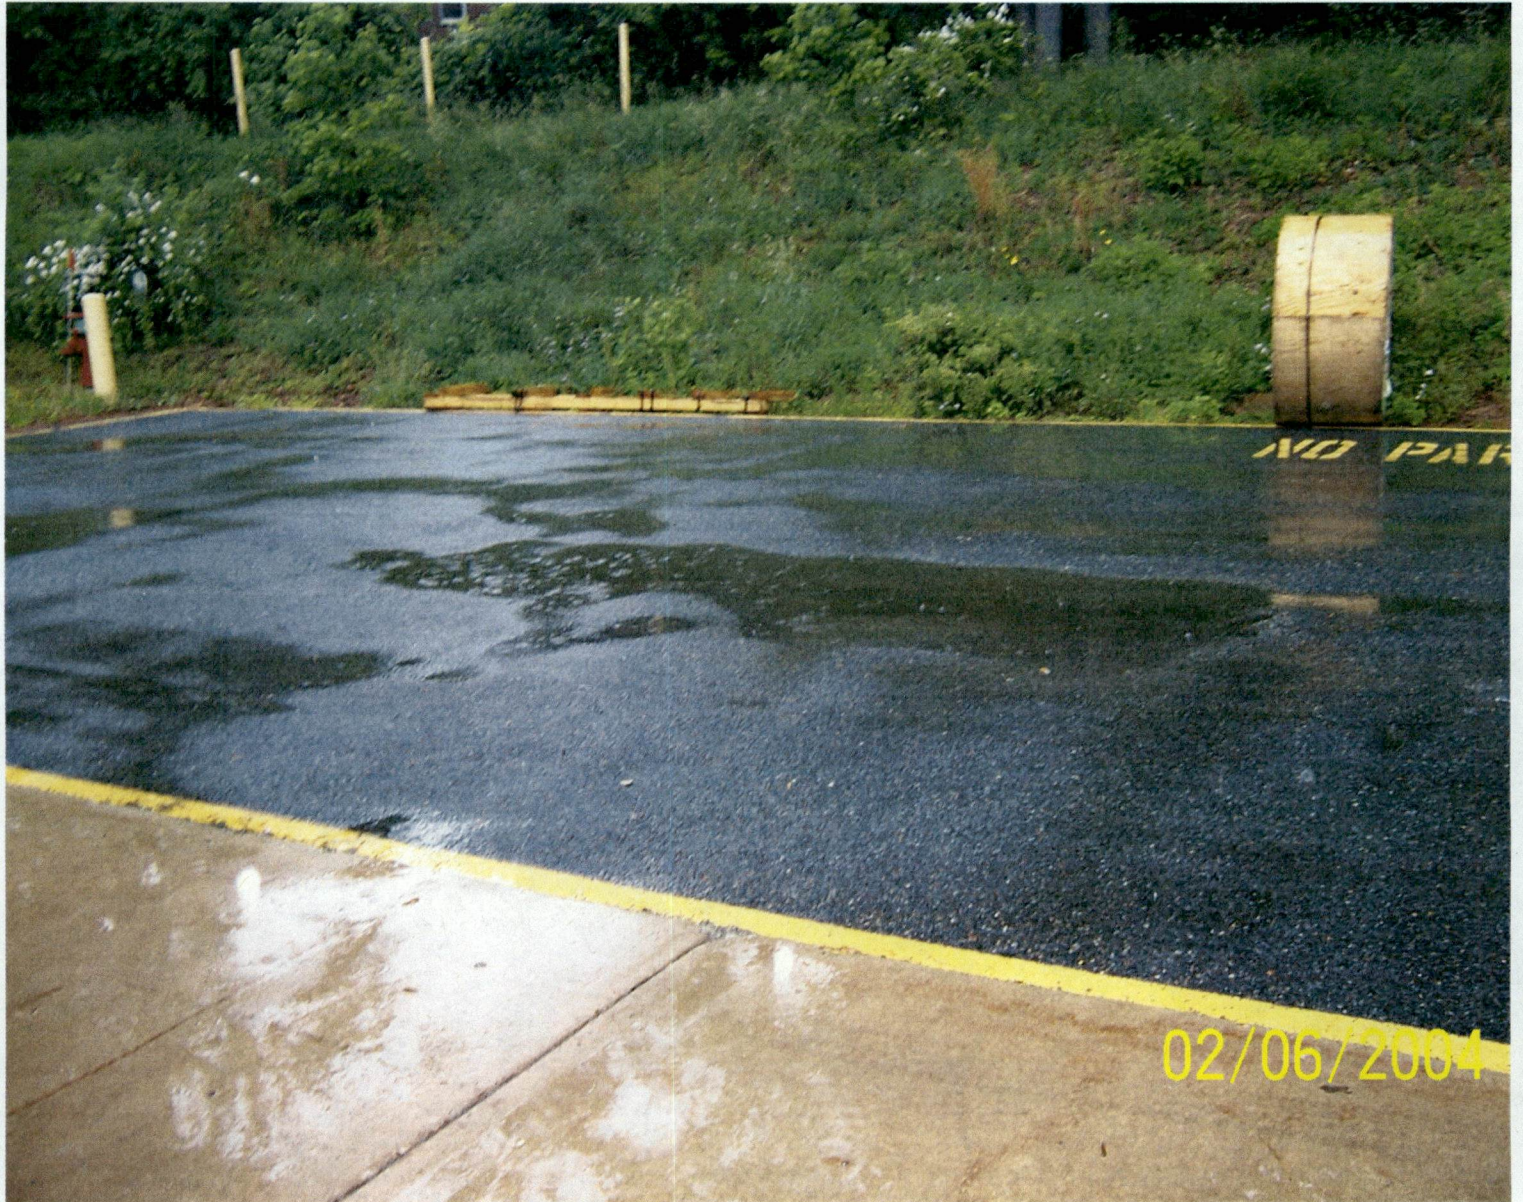
EPA Photo #8 SWMU 4 - Drainage
